RCRA PRELIMINARY ASSESSMENT/SITE INVESTIGATION PLAN
RAYMARK INDUSTRIES, INCORPORATED
Manheim, Pennsylvania 17545
PA D003015328

Final Report

June 1986

GCA CORPORATION
GCA TECHNOLOGY DIVISION, INCORPORATED
Bedford, Massachusetts 01730

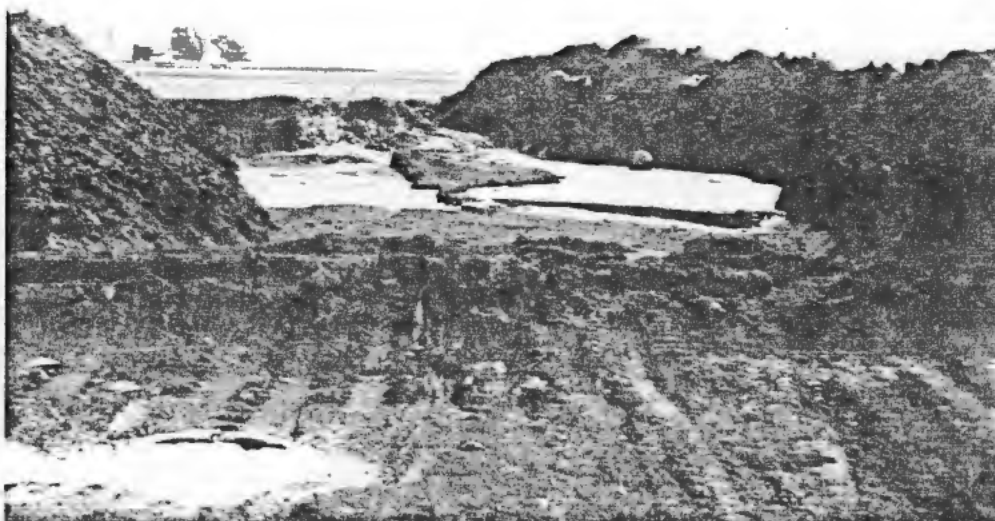
Description: An unlined earthen landfill located in the northeastern portion of the plant. The landfill operates under interim status. The waste design capacity of the landfill is approximately 43 acre-feet. The landfill includes an active portion which currently receives wastes and an inactive portion which is covered with a finished asphalt. In addition to not being equipped with a liner system, the current design of the landfill does not include a leachate collection system.

Description: The Hazardous Waste Landfill exclusively receives all of the estimated 9,663 tons of D008 waste annually generated at the facility. The D008 waste in the landfill is a slurry of asbestos, water, and dust laden with EP toxic levels of lead. The waste is primarily generated by the grooving, grinding, and drilling of clutch linings and brake facings. The dust produced during these machining operations is captured in a dust collection system and then mixed with water to eliminate airborne releases of asbestos. The waste slurry is hauled to the active portion of the landfill by means of a dumpster truck and deposited into one of three unlined trenches, each approximately 10 feet by 50 feet by 20 feet in size.

SWMU(1): Current Landfill, Active Portion, Front View

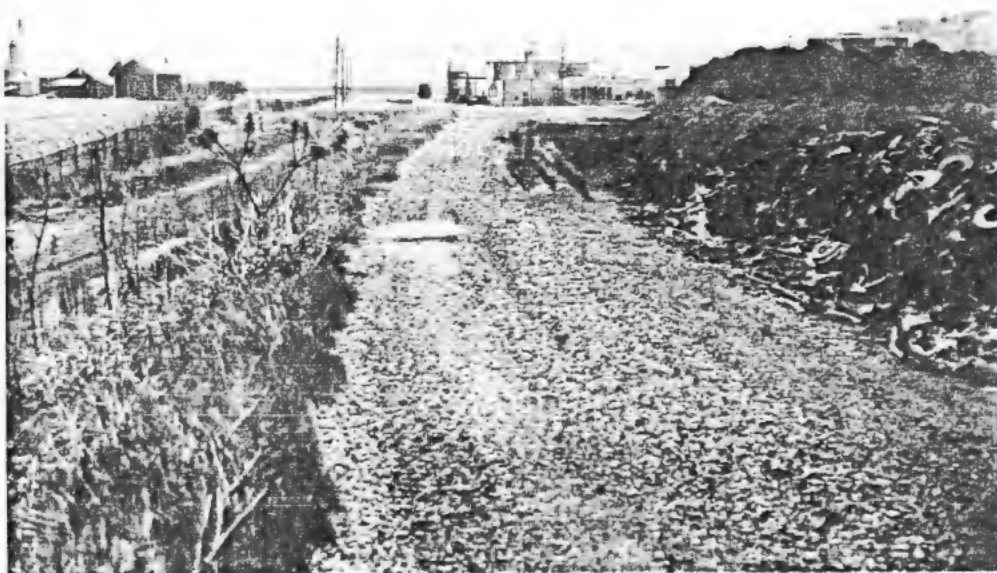
SWMU(1): Current Landfill, Rear View

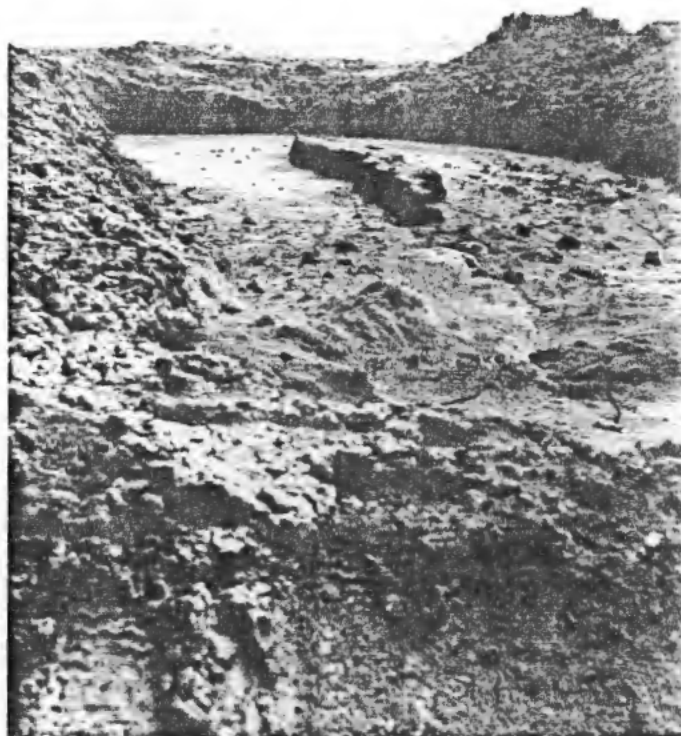
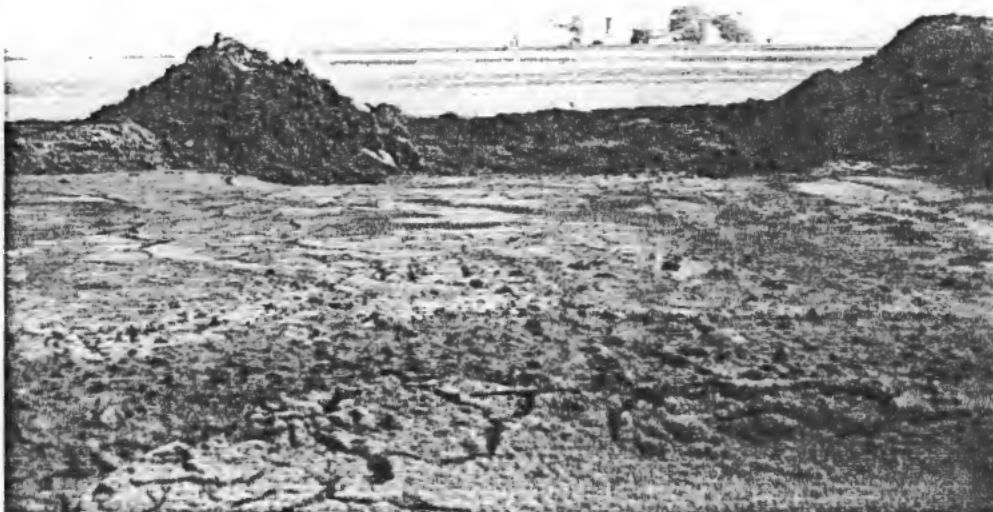
SWMU(1): Asbestos/Lead Slurry

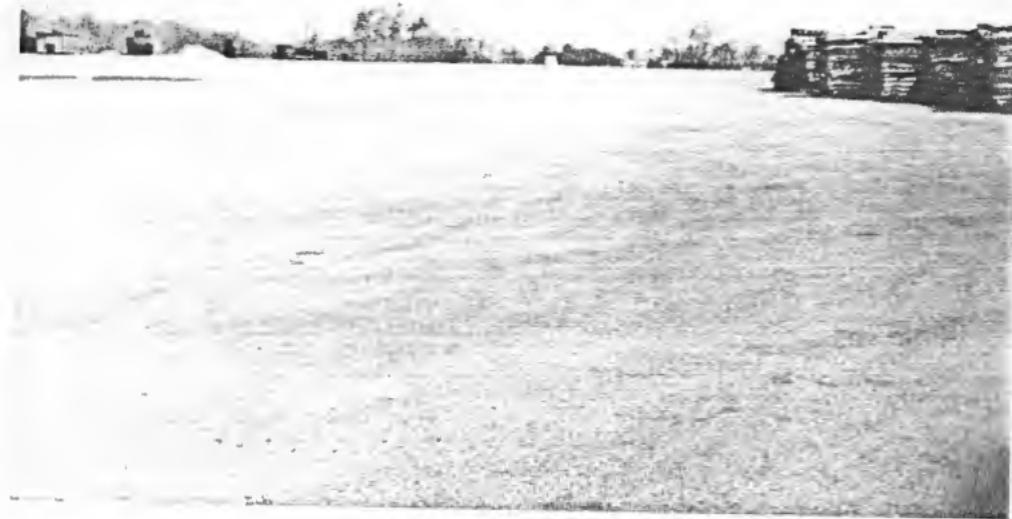
SWMU(1): Current Hazardous Waste Landfill - Inactive Portion

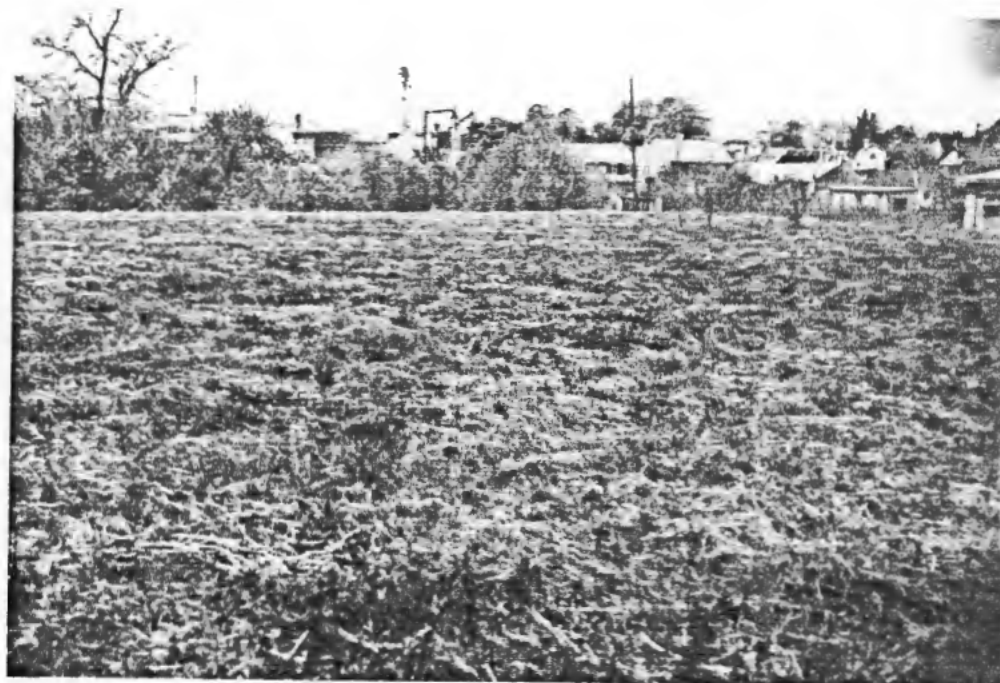
Description: A 450 foot by 260 foot unlined landfill located at the
 junction of Chickie's Creek and Doe Run tributary at the
 southwest corner of the plant.

Description: 700,000 cubic feet of asbestos and D008 wastes were disposed
 of in this unlined landfill. The unit was covered with soil
 and planted with crown vetch when operation ceased. No
 other information on management practices or closure were
 present in the PA DER and EPA files or available from the
 owner/operator. No environmental analyses of possible
 contamination from this unit have been conducted.

Releases: The apparent lack of engineering controls (i.e. liners and
 surface drainage controls) increases the likelihood that
 this unit poses a threat to ground water, soil and surface
 water.

SWMU(2): Former Hazardous Waste Landfill

SWMUs (2), (3) and (4), all inactive, unlined D008 and asbestos disposal landfills, are also recommended for an SI in order to develop a data base to assess their impact on ground water and other environmental media.

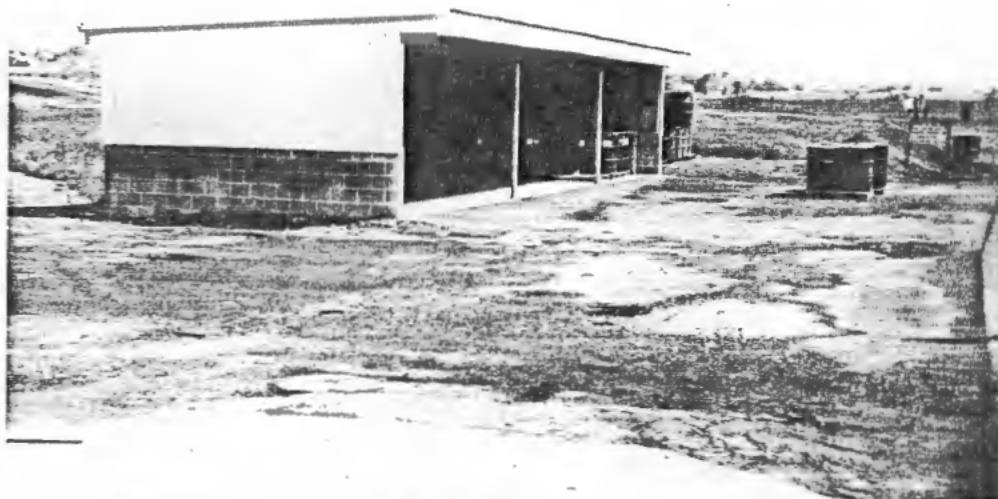
Releases: A March 3, 1984 PA DER RCRA inspection noted drums containing D001 waste had overflowed and spilled waste onto the ground. During a July 23, 1985 EPA/PA DER joint RCRA inspection, a small spill area, distressed vegetation, and elevated organic vapor analyzer (HNU) readings were observed between the storage area and Building 67.

Top: SWMU(5): Current drum storage area - collection trough.
Bottom: SWMU(5): Current drum storage area.

SWMU(5) is recommended for an SI to investigate the possibility that hazardous wastes were released into the soil underlying the pavement of the Current Drum Storage Area prior to the construction of the pad in 1981.

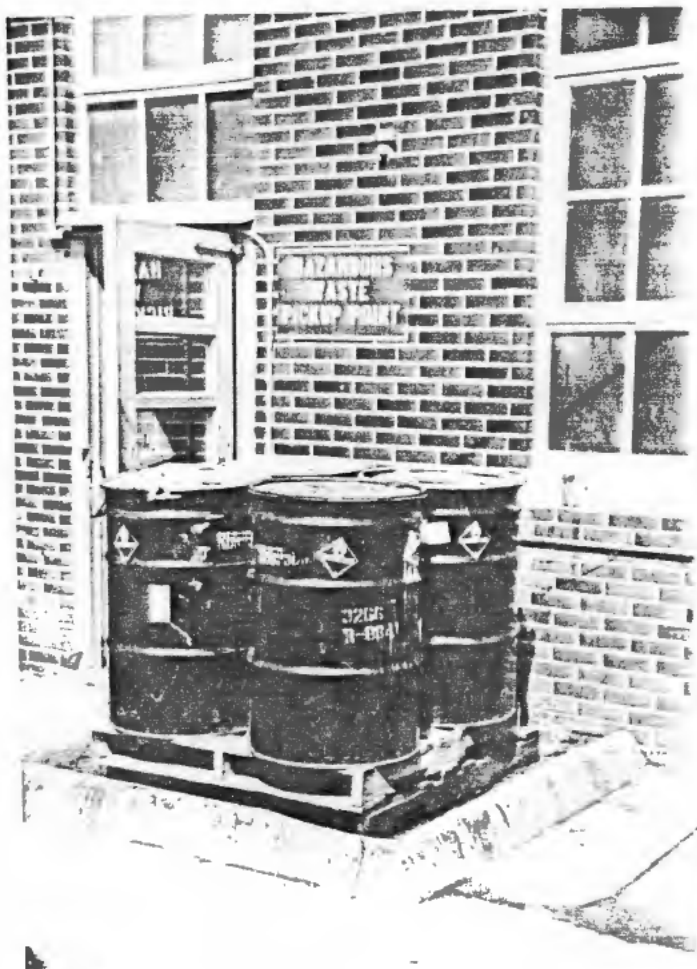
Description: Three onsite hazardous waste drum holding areas identified on the Raymark Part A Application Facility Drawing, but not included in Raymark's RSI #3 response. The units are all currently equipped with an asphalt floor and a six inch asphalt berm to contain spills. None of the units provide overhead shelter from precipitation events. The dates of construction of these units were not available. The locations and size of each of the units is as follows:

Description: These units are being or have been used as temporary holding areas for drummed hazardous wastes prior to the drums being transported to SWMU(5), the Current Drum Storage Area.

SWMU(7): Hazardous Waste Drum Holding Area

Similarly, because of uncertainty as to the dates of construction of the asphalt barriers and the possibility of prior soil contamination, SWMUs(6), (7), and (8) are included for evaluation in the SI. Finally, SWMU(9) is recommended for inclusion in an SI to further assess the adequacy of spill control measures and the impact that surface water drainage from these areas has on the lead content and overall quality of storm water runoff draining into Chickie's Creek.

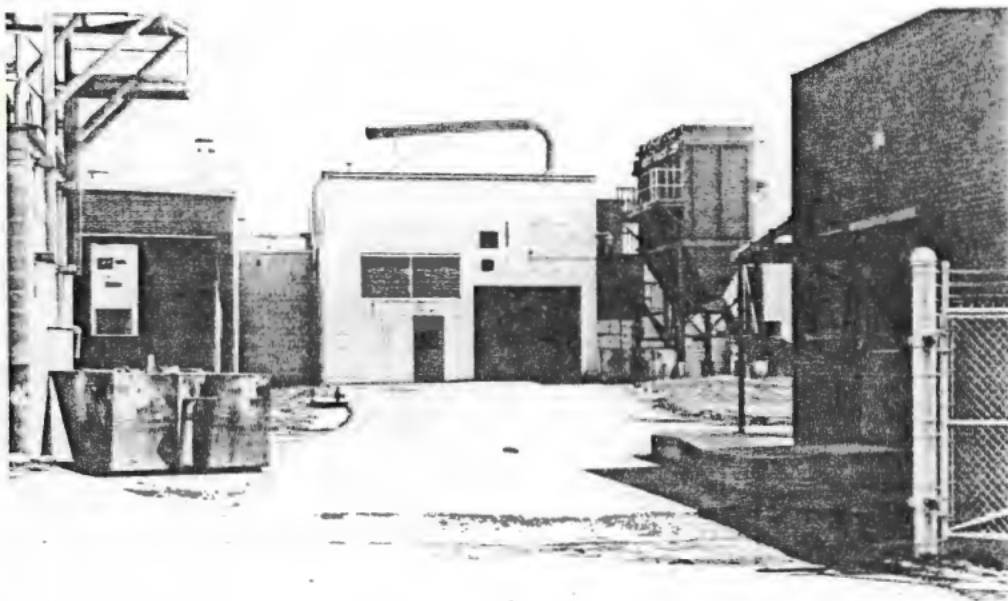
Releases: GCA/EPA personnel noted spillage of the waste slurry at many of the units during the May 7, 1986 site inspection.

SWMU(9): Asbestos/Lead Slurry Transfer Station - Covered
